PLAINWELL MILL REDEVELOPMENT

FEASIBILITY REPORT ON HISTORIC CAMPUS AND SURROUNDING SITE FOR THE CITY OF PLAINWELL, MICHIGAN

October 12, 2007

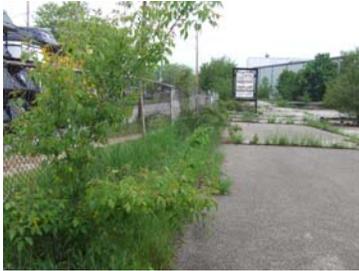
Current state of street frontage

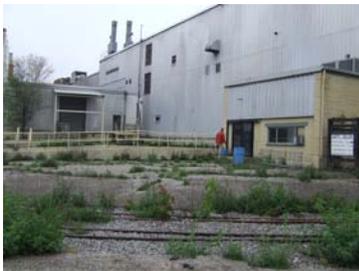
Remnants of pedestrian system

Interior site circulation: Currently there are only remnants of a pedestrian system that gave precedence to trucks and delivery more than workers and visitors. To meet current universal access / barrier free considerations, as well as effectively connect to the downtown, an entirely new non-motorized pathway needs to be designed and constructed. One prominent example is the Mill Race walkway – it currently has three areas of steps, is extremely narrow, and is not lighted. The proposed construction of a Riverwalk will greatly aid interior circulation by establishing a hierarchy of pathways (all roads and future pathways should intuitively connect to the Riverwalk) and offering an easy connection to the downtown.

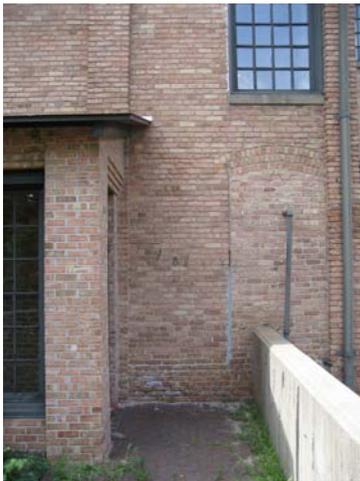
B18 entry through vestibule to the left. A bricked up window is to the right.

With B18's location adjacent to the mill race, it makes sense to keep this building as the main entry to the complex. The existing non-original vestibule should be removed and replaced by a larger more spacious transitional or vestibule space.

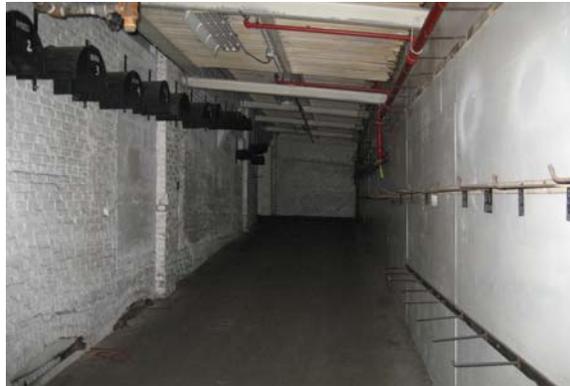
Ramp with bricked up windows leading to B19 on left

The current experience walking through these buildings is very dark and enclosed. There are bricked up windows on the B19 side of the ramp which could be opened up to create more openness and transparency. The partition between the ramp and the turbine room can be removed and the east wall toward the mill race opened up to bring light into the space. It would be interesting to create a display in this area on the history of the mill, and capitalize on its circulation function to the potential council chambers in B19. The water flowing under the building will require continual maintenance and some thought should be given to whether or not the trash rack needs to be kept in place if the turbine is not being used, and even as to whether the water should be allowed to continue running under the building.

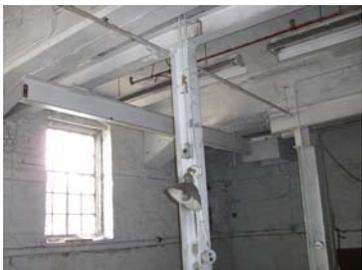
B18 River Level structure

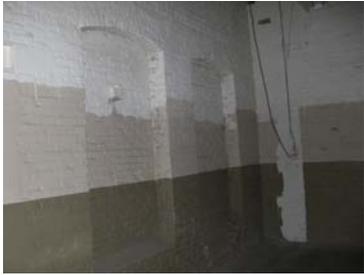
Bricked up window openings

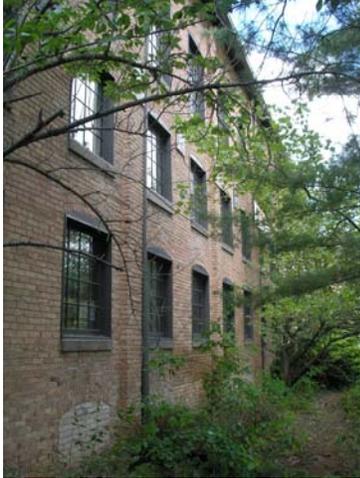
B17 east elev with steel plates

At the underside of the second floor, the majority of the timber beams that bear into the exterior walls have been retrofitted with a pair of steel rods passing through the walls and through a steel plate added to the exterior of the wall. Numerous timber columns have been damaged due to collisions by mill equipment. Many columns and beams have been replaced with structural steel members. There are some isolated areas where the exterior masonry walls have badly deteriorated and will require repair. There is a concrete haunch supporting the end of a timber beam at the wall common with Building 12 that is severely cracked. This beam end should be shored up immediately and the shoring maintained until permanent repairs can be made. Any similarly cracked haunches that may be present should also have the beams shored. The concrete window sills are very porous and weathered in appearance.

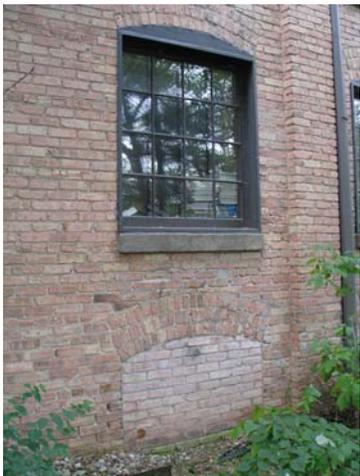
B17 main level window, bricked-up basement window below

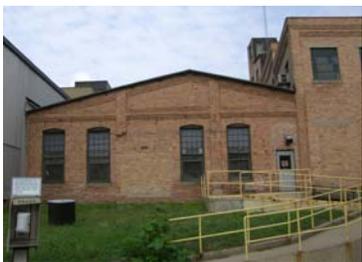
East end B16 w/ missing pier

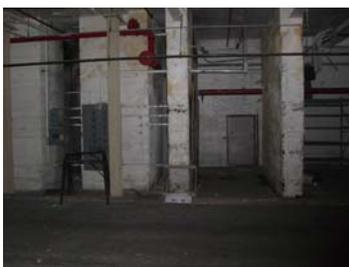
B15 basement structure supports 1000#/square foot
