PLAINWELL MILL REDEVELOPMENT

FEASIBILITY REPORT ON HISTORIC CAMPUS AND SURROUNDING SITE FOR THE CITY OF PLAINWELL, MICHIGAN

October 12, 2007

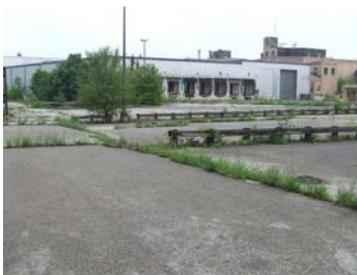
Paving over site

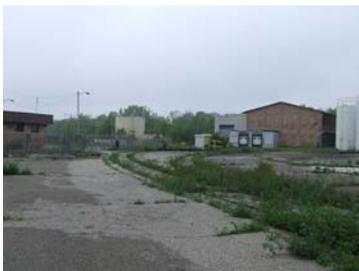
Industrial circulation remnants

Another interior site circulation issue is the lack of defined roads. Having no curbs, street lights, signage, or other standard cues, the only regulating force for cars and trucks are the existing buildings, changes in topography, and industrial remnants left throughout the site. A fully defined street network that connects at the appropriate locations (aligned with existing streets, with the potential for signalization) will need to be designed and built. Additional right of ways / easements may need to be built or set aside when in proposed open space areas to facilitate safe emergency access points to the Mill's less accessible areas.

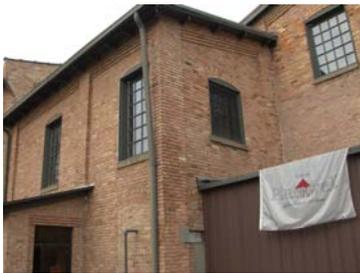
B18 exterior

With B18's location adjacent to the mill race, it makes sense to keep this building as the main entry to the complex. The existing non-original vestibule should be removed and replaced by a larger more spacious transitional or vestibule space.

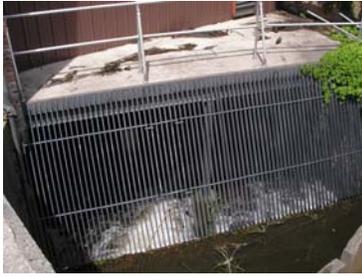
Trash rack where water flows beneath B20/20A

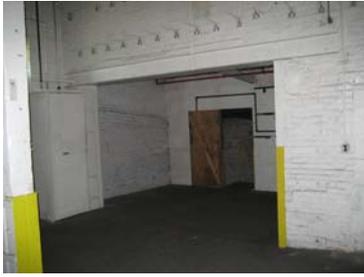
View of top of ramp in B20/20A

The current experience walking through these buildings is very dark and enclosed. There are bricked up windows on the B19 side of the ramp which could be opened up to create more openness and transparency. The partition between the ramp and the turbine room can be removed and the east wall toward the mill race opened up to bring light into the space. It would be interesting to create a display in this area on the history of the mill, and capitalize on its circulation function to the potential council chambers in B19. The water flowing under the building will require continual maintenance and some thought should be given to whether or not the trash rack needs to be kept in place if the turbine is not being used, and even as to whether the water should be allowed to continue running under the building.

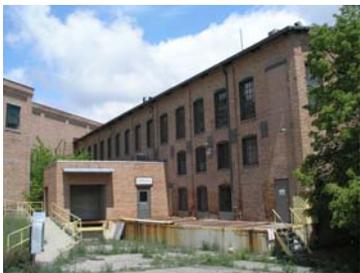
B17 loading dock and west elev.

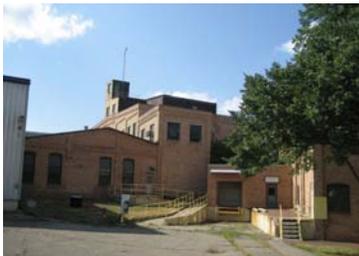
High south end of B12 over B16

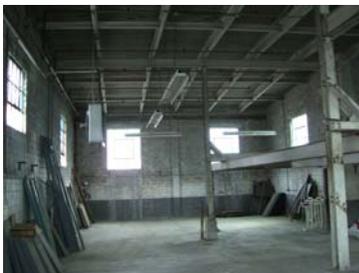
Interior of penthouse

Building 12 has a penthouse that sticks up above the roof. The penthouse floor is framed several feet below the level of the roof structure, which prohibits views out the windows except for the sky. It is through this penthouse that access is gained to the roof. The floor structure of the penthouse is framed-in at a lower elevation than roof framing. The roof membrane is roll roofing sealed with bituminous sealer between the various edges of the sheets.

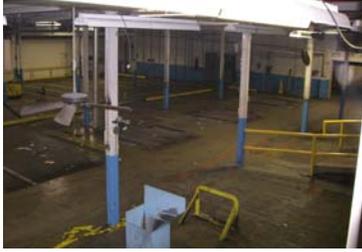
This building is very adaptable for reuse because of its openness and large bays. Natural light is almost non-existent on the basement and main levels because of its location in the middle of the site. The building is in good condition.

B12 Main Level, large open bays

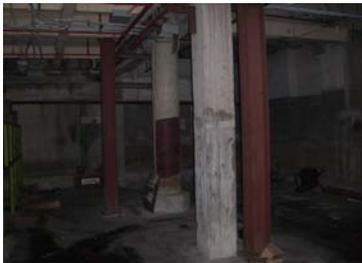
B12 Basement Level

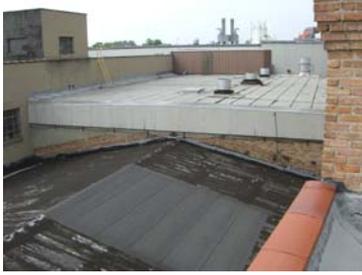
Building 16 has a basement and main level of 3,800 square feet each. It has exterior masonry bearing walls and a heavy timber roof and floor structure. The roof is a gable roof and has a bituminous roof membrane that is old and heavily patched. In the lower level some timber columns have been replaced by steel wide flange columns. It appears there are two hydraulic lifts in the main floor of Building 16 that raise and lower rectangular floor panels. The main floor has a concrete surface, but wooden deck. Brick piers on the exterior face were partially removed. The basement is currently chopped up with columns. The main floor is very open with a single row of columns. Some window openings are bricked in but discernible and the wood roof structure is exposed. The building is in fair condition with some minor water infiltration. The roof may need a new membrane.

Roof of B16 in front, B15 in back

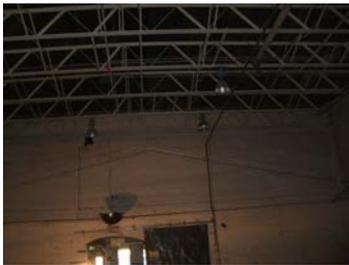
B15 showing old roof line

Building 15 has a basement and main level of 4,000 square feet each. The structure is brick walls, concrete floor (installed in 1990), and steel roof trusses with a wood deck. The building has been modified as evidenced by the shadow of a former roof line. Minimal historic material remains. The floor capacity of the main level is 1000# per square foot and because of this; the basement is currently chopped up with columns and massive concrete piers. The main floor is completely open, but there are no windows because of the adjacent buildings.

The upper portion of B15 is proposed to be removed both because of its lack of historic integrity and to allow more natural light into Building 12. The main floor and structure below could remain to create an outdoor plaza and the space below used for either parking or storage.

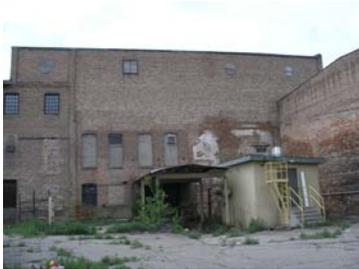
North elevation of B11 showing 2nd floor addition and mech penthouse over B19 to the left

Building 11 has a basement, main and second level of 9,100 square feet each. The structure is brick walls, concrete floor and steel beam roof structure with wood ceiling. The basement and main level were built in 1906 and in 1960; a high second level was added contiguous with B12's second level. The addition has few windows and the brick does not match the original. The walls were built on top of the masonry brick walls.

The upper part of B11 is proposed to be removed because of its lack of historic integrity and to allow more natural light into Building 12. The main floor and structure below could remain to create an outdoor plaza and the space below used for either recreation or commercial/retail.

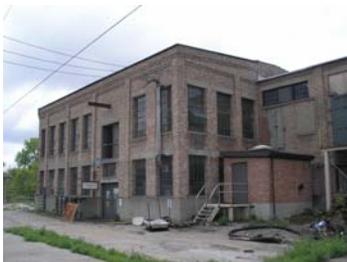
B11A exterior view from river

Building 11A has a basement and main level of 4,600 square feet each. The structure is brick walls, concrete floor, cast-in-place concrete foundations and structure at the basement level, and a steel truss roof structure with wood ceiling. The east wall is bowing outward. Several of the concrete columns have significant cracking where they join to the beams of the main floor level. There is cracking of the north exterior wall around the centrally located double wide door opening. The two concrete columns of the main floor with cracks at their joints with the supported beams are interior to and adjacent to this door opening.

The reason for the cracking must be found and the cracking repaired at the two cracked columns prior to putting the building back into service. The spaces at each level are open with many large steel windows overlooking the river. The space inside is open, has high ceilings, and has a high degree of historic integrity.

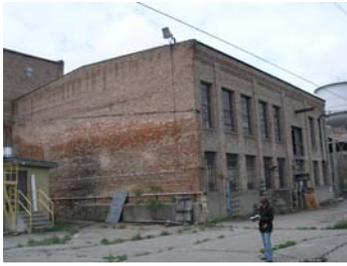
B16 east exterior elevation

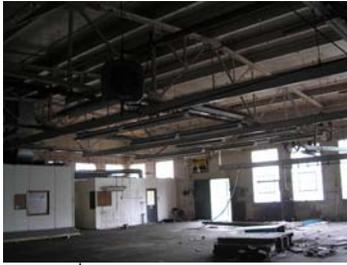
B16 2nd level light-filled interior
