PRIORITY SITE #1

Plainwell Paper Mill – <u>Building Complex</u>

Plainwell is an equal-opportunity provider and employer <u>www.Plainwell.org</u> Updated 11/2022 Site Name: Plainwell Paper Mill – Building Complex

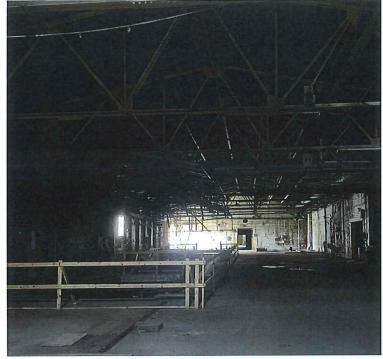
Building 10 - Location Diagram

Building 10 has a basement and main level of 12,180 square feet each. The main floor is a reinforced concrete structural system with poured-in-place columns, beams, and slabs. There is one very large floor opening that appears to have been for a large piece of equipment. The roof is clear-span steel gable trusses with a timber roof deck.

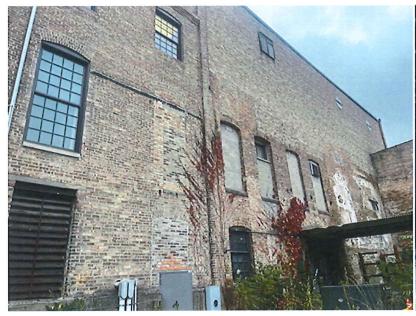
Building 11 - Location Diagram

Building 11 has a basement, main and second level of 9,100 square feet each. The structure is brick walls, concrete floor and steel beam roof structure with wood ceiling. The basement and main level were built in 1906 and in 1960; a high second level was added contiguous with B12's second level. The addition has few windows and the brick does not match the original. The walls were built on top of the masonry brick walls.

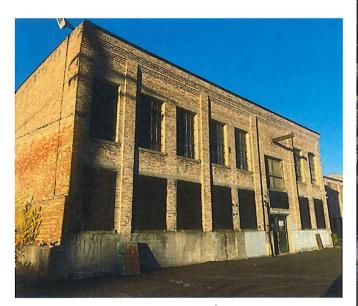
Building 11A - Location Diagram

Building 11A has a basement and main level of 4,600 square feet each. The structure is brick walls, concrete floor, cast-in-place concrete foundations and structure at the basement level, and a steel truss roof structure with a wood ceiling. The east wall is bowing outward. Several of the concrete columns have significant cracking where they join to the beams of the main floor level. There is cracking of the north exterior wall around the centrally located double-wide door opening. The two concrete columns of the main floor with cracks at their joints with the supported beams are interior to and adjacent to this door opening.

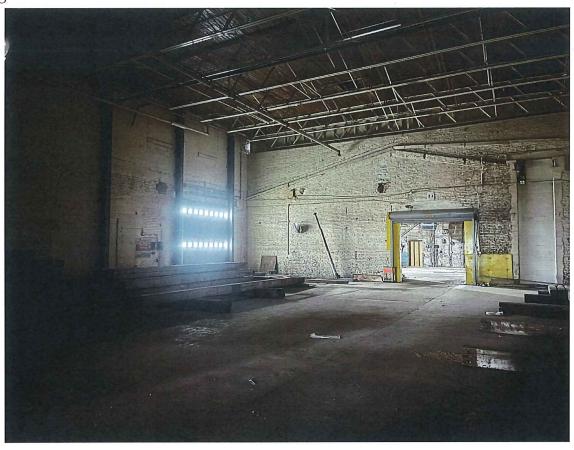
Building 15 - Location Diagram

Building 15 has a basement and main level of 4,000 square feet each. The structure is brick walls, a concrete floor (installed in 1990), and steel roof trusses with a wood deck. The building has been modified as evidenced by the shadow of a former roof line. Minimal historic material remains. The floor capacity of the main level is 1000# per square foot and because of this; the basement is currently chopped up with columns and massive concrete piers. The main floor is completely open, but there are no windows because of the adjacent buildings.

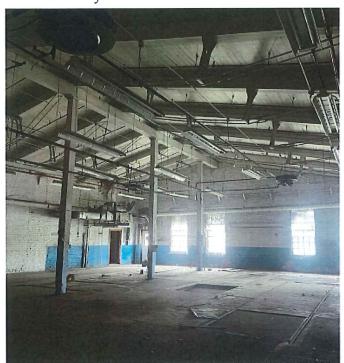
Building 16 - Location Diagram

Building 16 has a basement and main level of 3,800 square feet each. It has exterior masonry-bearing walls and a heavy timber roof and floor structure. The roof is a gable roof and has a bituminous roof membrane that is old and heavily patched. In the lower level, some timber columns have been replaced by steel wide flange columns. It appears there are two hydraulic lifts on the main floor of Building 16 that raise and lower rectangular floor panels. The main floor has a concrete surface, but a wooden deck. Brick piers on the exterior face were partially removed. The basement is currently chopped up with columns. The main floor is very open with a single row of columns. Some window openings are bricked in but discernible and the wood roof structure is exposed. The building is in fair condition with some minor water infiltration. The roof may need a new membrane.
